**DEPARTMENT OF TRANSPORTATION**

Contract #: 04-0120F4Cty: SF/ALA Rte: 80 PM: 13.2/13.9File #: 69.28**WELDING INSPECTION REPORT****Resident Engineer:**Siegenthaler, Peter**Address:** 333 Burma Road**City:** Oakland, CA 94607**Report No:** WIR-020088**Date Inspected:** 27-Jan-2011**Project Name:** SAS Superstructure**OSM Arrival Time:** 700**Prime Contractor:** American Bridge/Fluor Enterprises, a JV**OSM Departure Time:** 1900**Contractor:** Zhenhua Port Machinery Company, Ltd (ZPMC), Changxing Island **Location:** Shanghai, China**CWI Name:** Xu tao**CWI Present:** Yes No**Inspected CWI report:** Yes No N/A**Rod Oven in Use:** Yes No N/A**Electrode to specification:** Yes No N/A**Weld Procedures Followed:** Yes No N/A**Qualified Welders:** Yes No N/A**Verified Joint Fit-up:** Yes No N/A**Approved Drawings:** Yes No N/A**Approved WPS:** Yes No N/A**Delayed / Cancelled:** Yes No N/A**Bridge No:** 34-0006**Component:** OBG Components**Summary of Items Observed:**

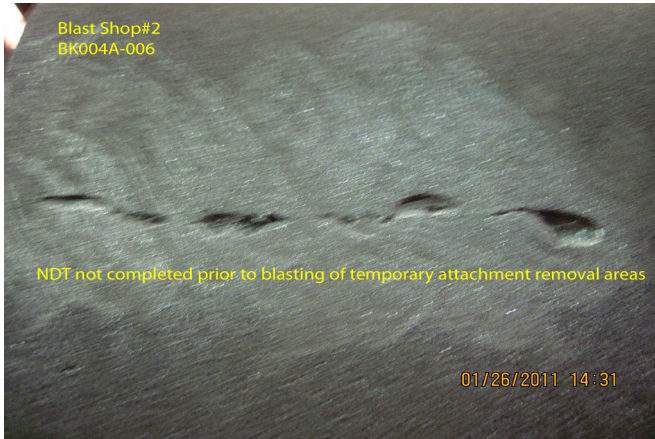
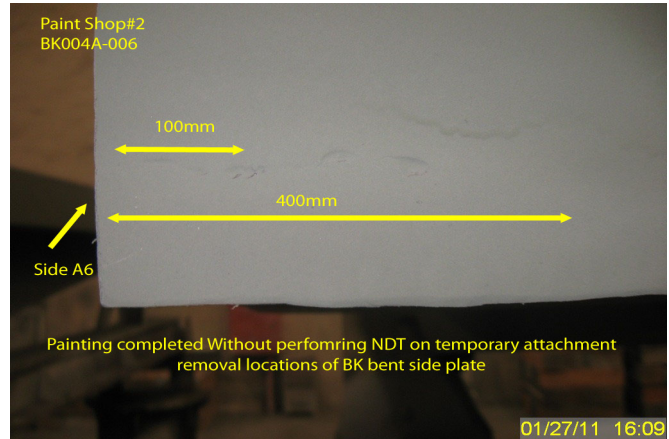
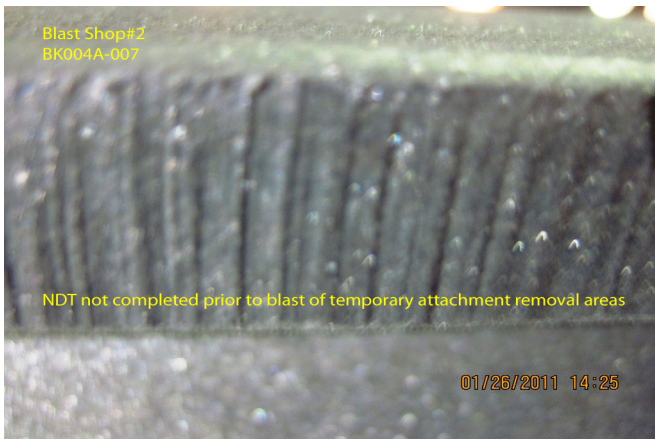
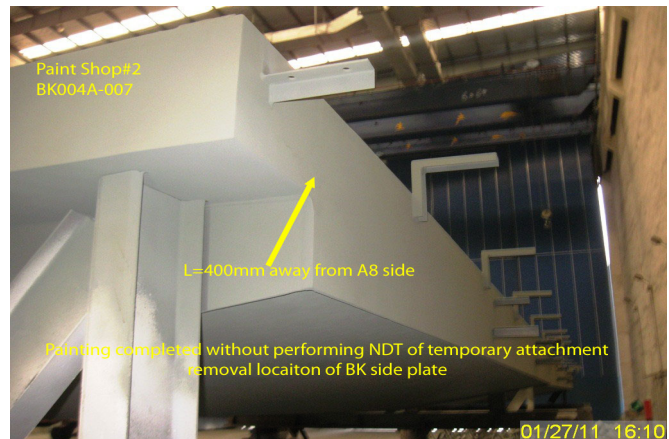
The Caltrans Quality Assurance (QA) Inspector observed that the Bike path BK004A -006 and BK004A-007 had been moved to the blast shop and then Paint shop on January 27th , prior to the completion of the following NDT work.

1. NDT on temporary attachment (Lifting lugs) removal location on the side plates BKPL3A and BKPL3B was not been performed.

2. The Y locations are

400mm away from end closure plate BKPL8A and BKPL8B on the side plates BKPL3A and BKPL3B of Bike path BK004A-006 and BK004A-007.
